Water quality of streams flowing through Virginia golf courses

A three-year study monitoring the water quality of streams flowing through nine golf courses within a sub-watershed of Chesapeake Bay showed the courses did not contribute to water degradation of the bay.

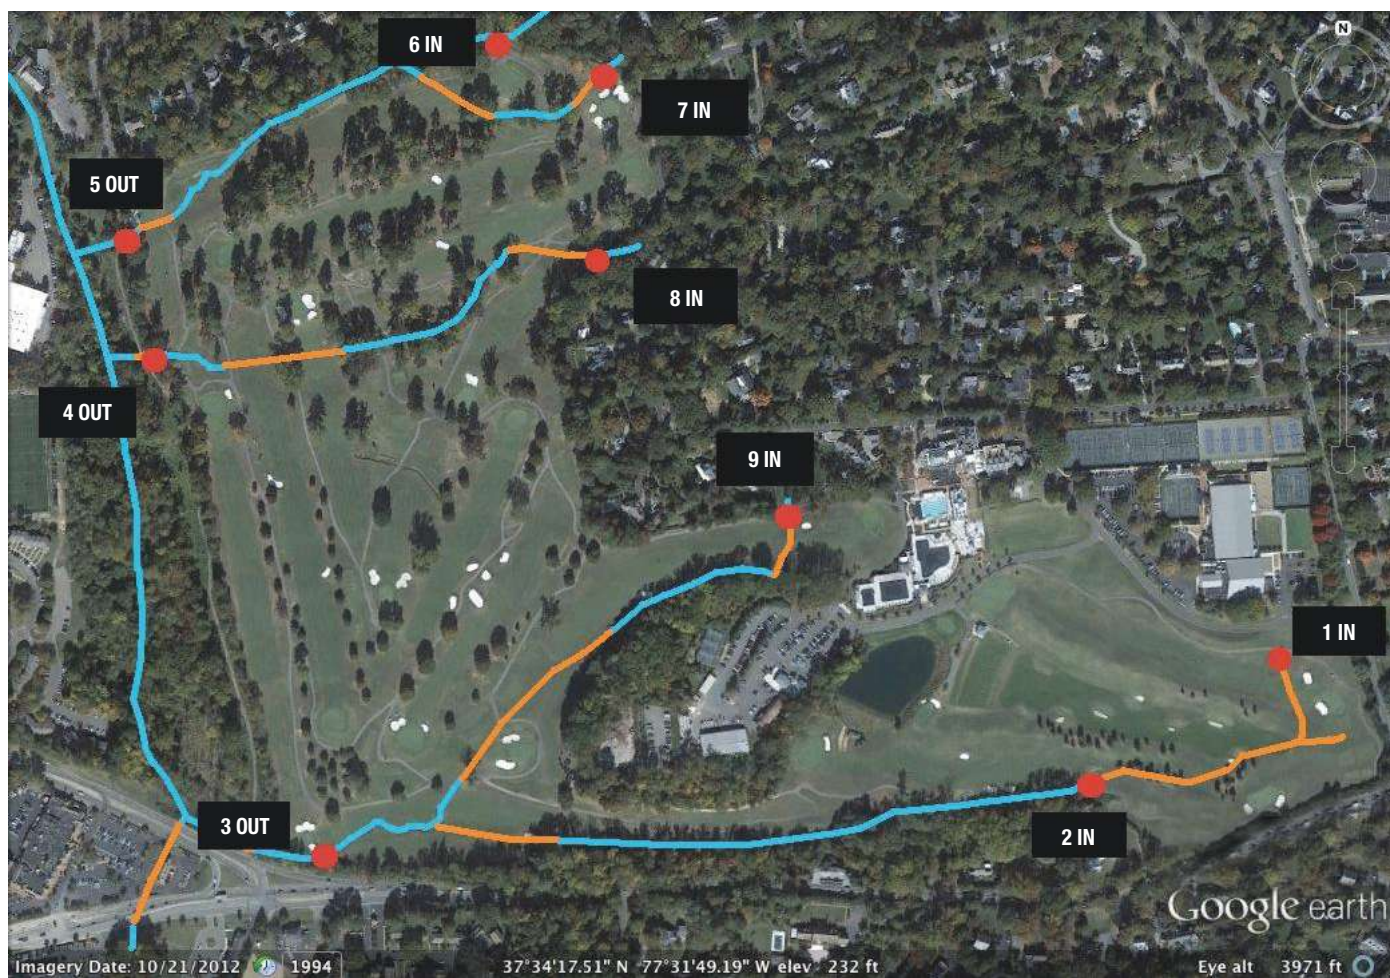
Figure 1. Stream sampling locations were identified at each golf course, with water collected at upstream locations where streams enter the course (inflows), and at downstream locations where streams exit the course (outflows). Course 5 is shown.

Stream sampling locations were identified at each golf course, with water collected at upstream locations where streams enter the course (inflows), and at downstream locations where streams exit the course (outflows) (Figure 1). Upstream water sample collection sites served as baseline reference conditions

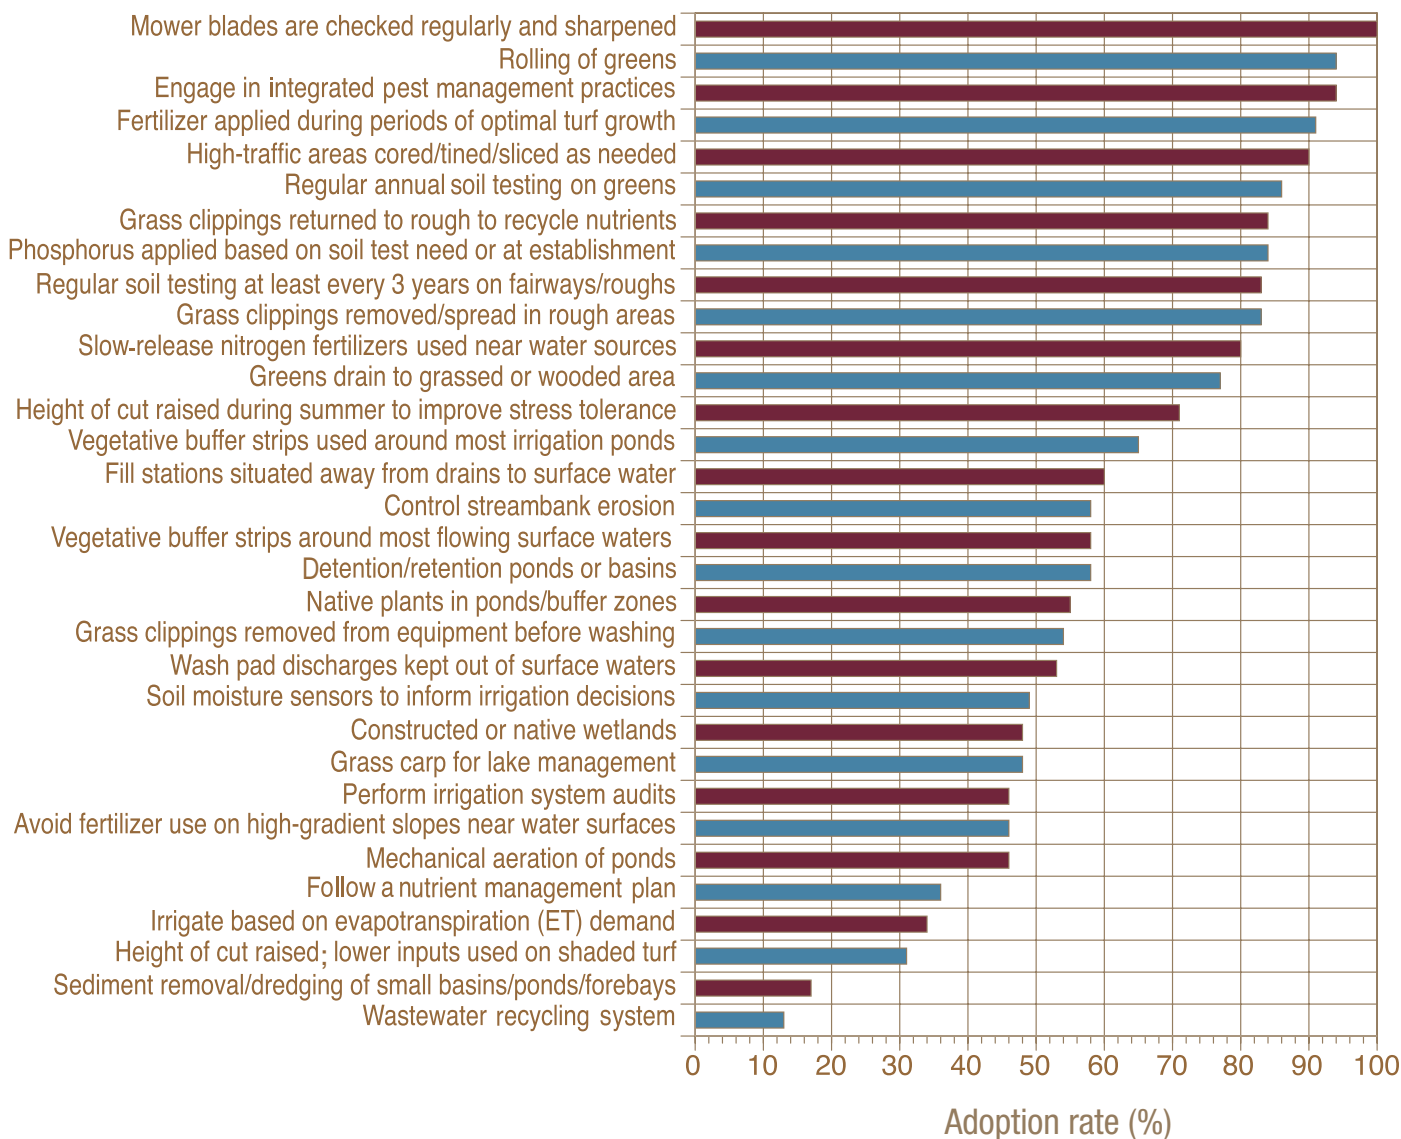
BMP adoption rates

Figure 5. Percent adoption rate, self-reported by 70 Virginia golf course superintendents, of recommended BMPs for water quality protection.

Results of the online survey completed by 70 Virginia golf courses located in the Chesapeake Bay area revealed that many of the BMPs recommended in the 2012 Virginia GCSA guidelines (5) were in use (Figure 5). For example, water-quality protection BMPs with a greater than 50% adoption rate included:

- Use of slow-release nitrogen fertilizers near water sources
- Greens drained to grassed or wooded areas
- Vegetative buffer strips used around most irrigation ponds
- Fill stations situated away from drains to surface water
- Control of stream bank erosion
- Vegetative buffer strips used around most flowing surface waters
- Use of detention or retention ponds or basins
- Use of native plants in ponds or buffer zones
- Grass clippings removed from equipment before washing
- Wash pad discharges kept out of surface waters
